## Novel Full-chip Verification Methodologies for Domain-crossing and Transient Latch-up Damage Prevention

<u>David Klein, (Synaptics)</u>, Yuri Feinberg, Simon Young, (Silicon Frontline Technology)

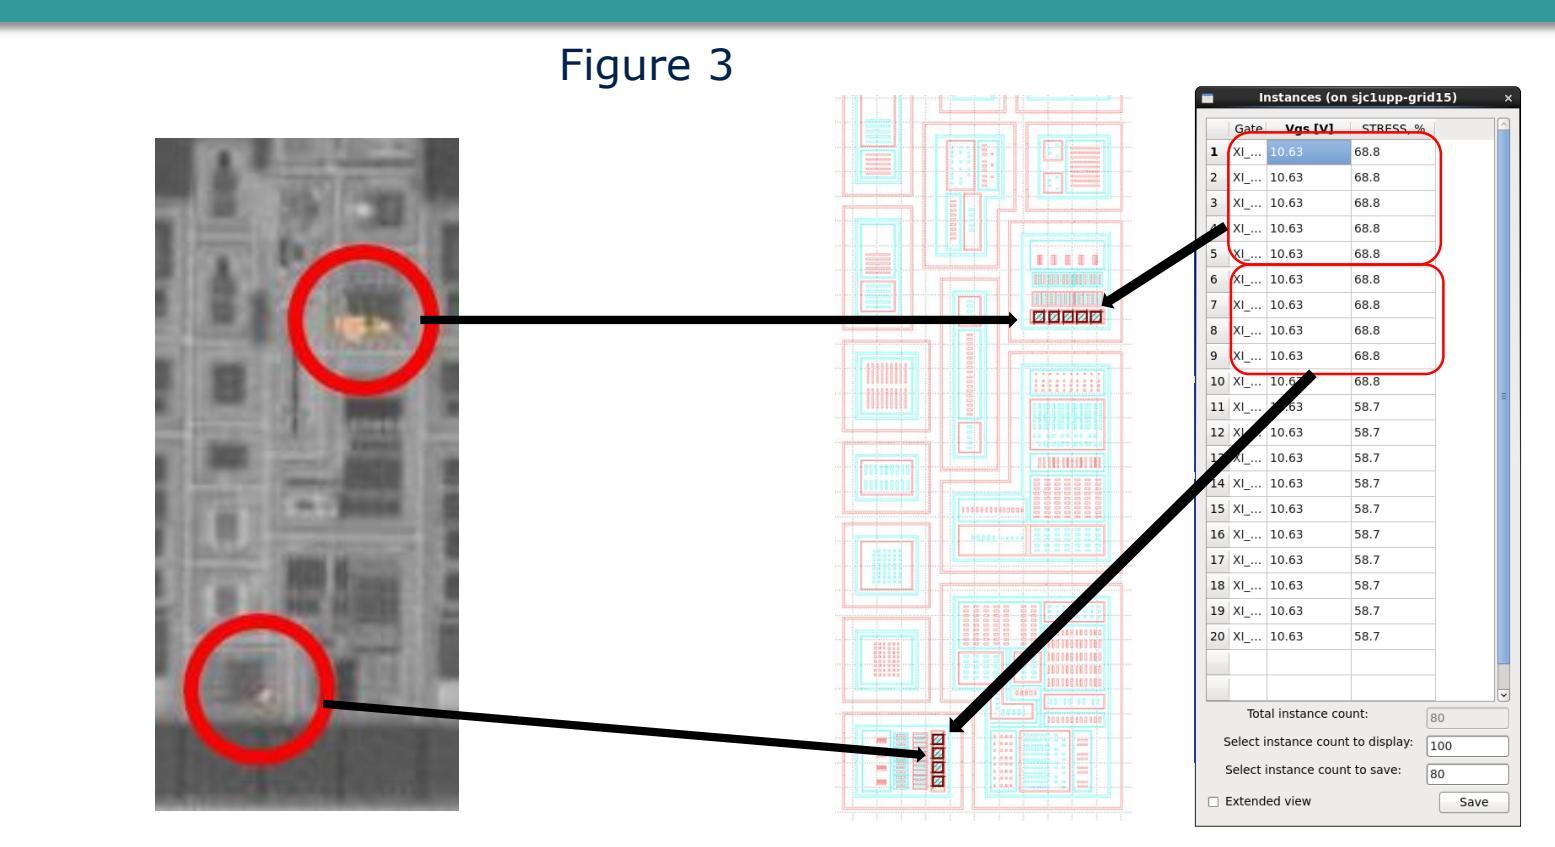
- Failure only occurred during IEC-61000-4-2 contact discharge to the ground plane of the fPCB that was part of a face down display module. The damage was to the integrated touch and display driver ASIC which was fully operational during the test
- □ ASIC level FDCDM testing did not replicate the failure
- Abnormal photoemission is shown in Figure 3 along with analysis results
- Failure investigation using the CDM analysis tool
  - □ Simulation current is set to 10A
  - □ Figure 4 lists the overstress D/R pairs in the suspicious region
  - □ The "STRESS, %" is the percentage of overstress. For example, "68.8%" means the V<sub>GS</sub> on receiver is 1.688 higher than the breakdown voltage V<sub>BDOX</sub>

Left: Photoemission at the failure locations in the receivers. During this capture, the ASIC is powered up and operational with only the functionality of this block compromised.

Please note: After IEC stress, a random distribution of the devices in the circled areas would be damaged

Right: The D/R pairs found by the tool to be at risk

- In this design, the driver and receiver use the same analog ground. There is relatively high resistance between the core ground and the analog ground at this location allowing for large core V<sub>DD</sub> to analog ground voltage buildup.
- Inspection of the layout showed no nearby anti-parallel diodes between the core and analog ground nets
- Anti-parallel diodes were added between these two grounds near the at-risk NMOS as shown in Figure 5
  - After these diodes were added, simulation no longer shows overstress in this region
  - The new silicon passed the IEC-61000-4-2 test

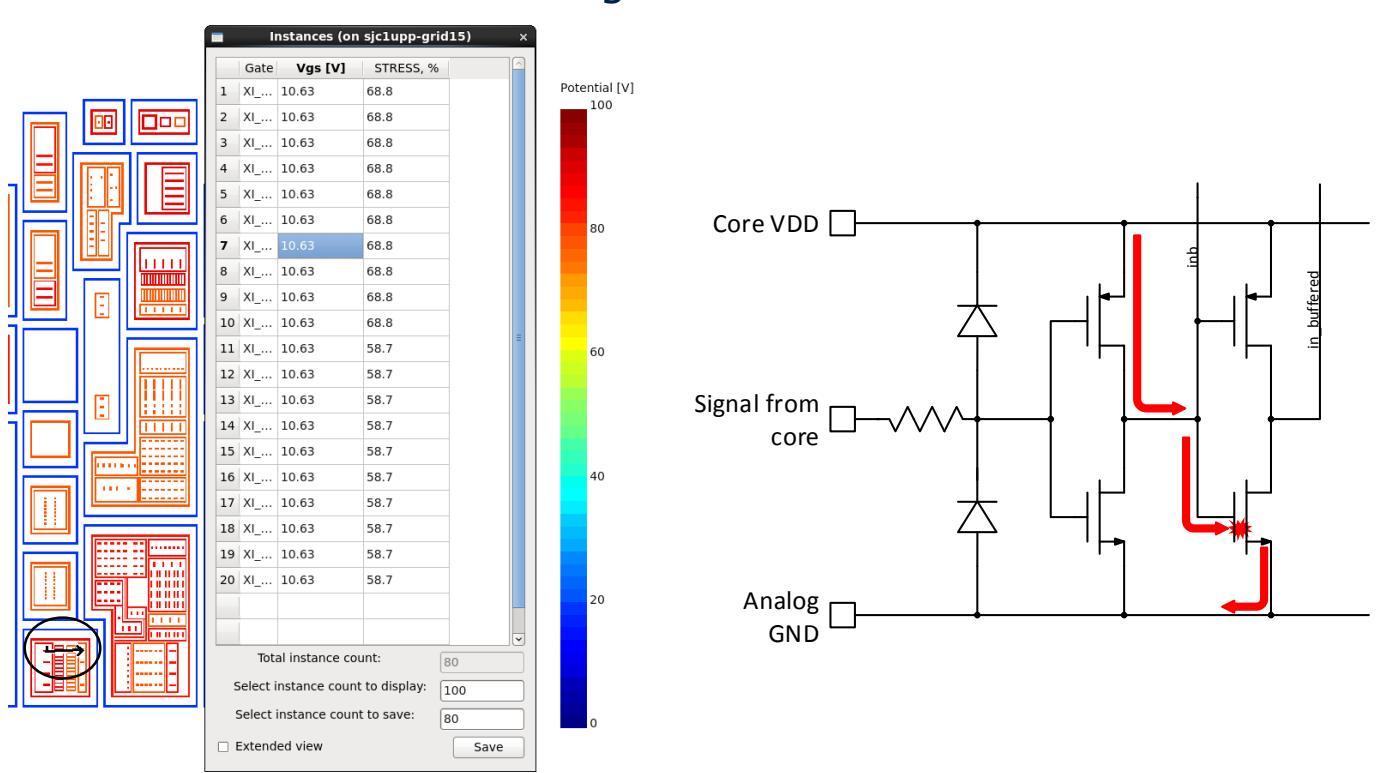
Figure 4.

Left: List of overstressed D/R pairs. The circled black arrow highlights the path from driver to receiver.

Right: The schematic with discharge path of the D/R pair

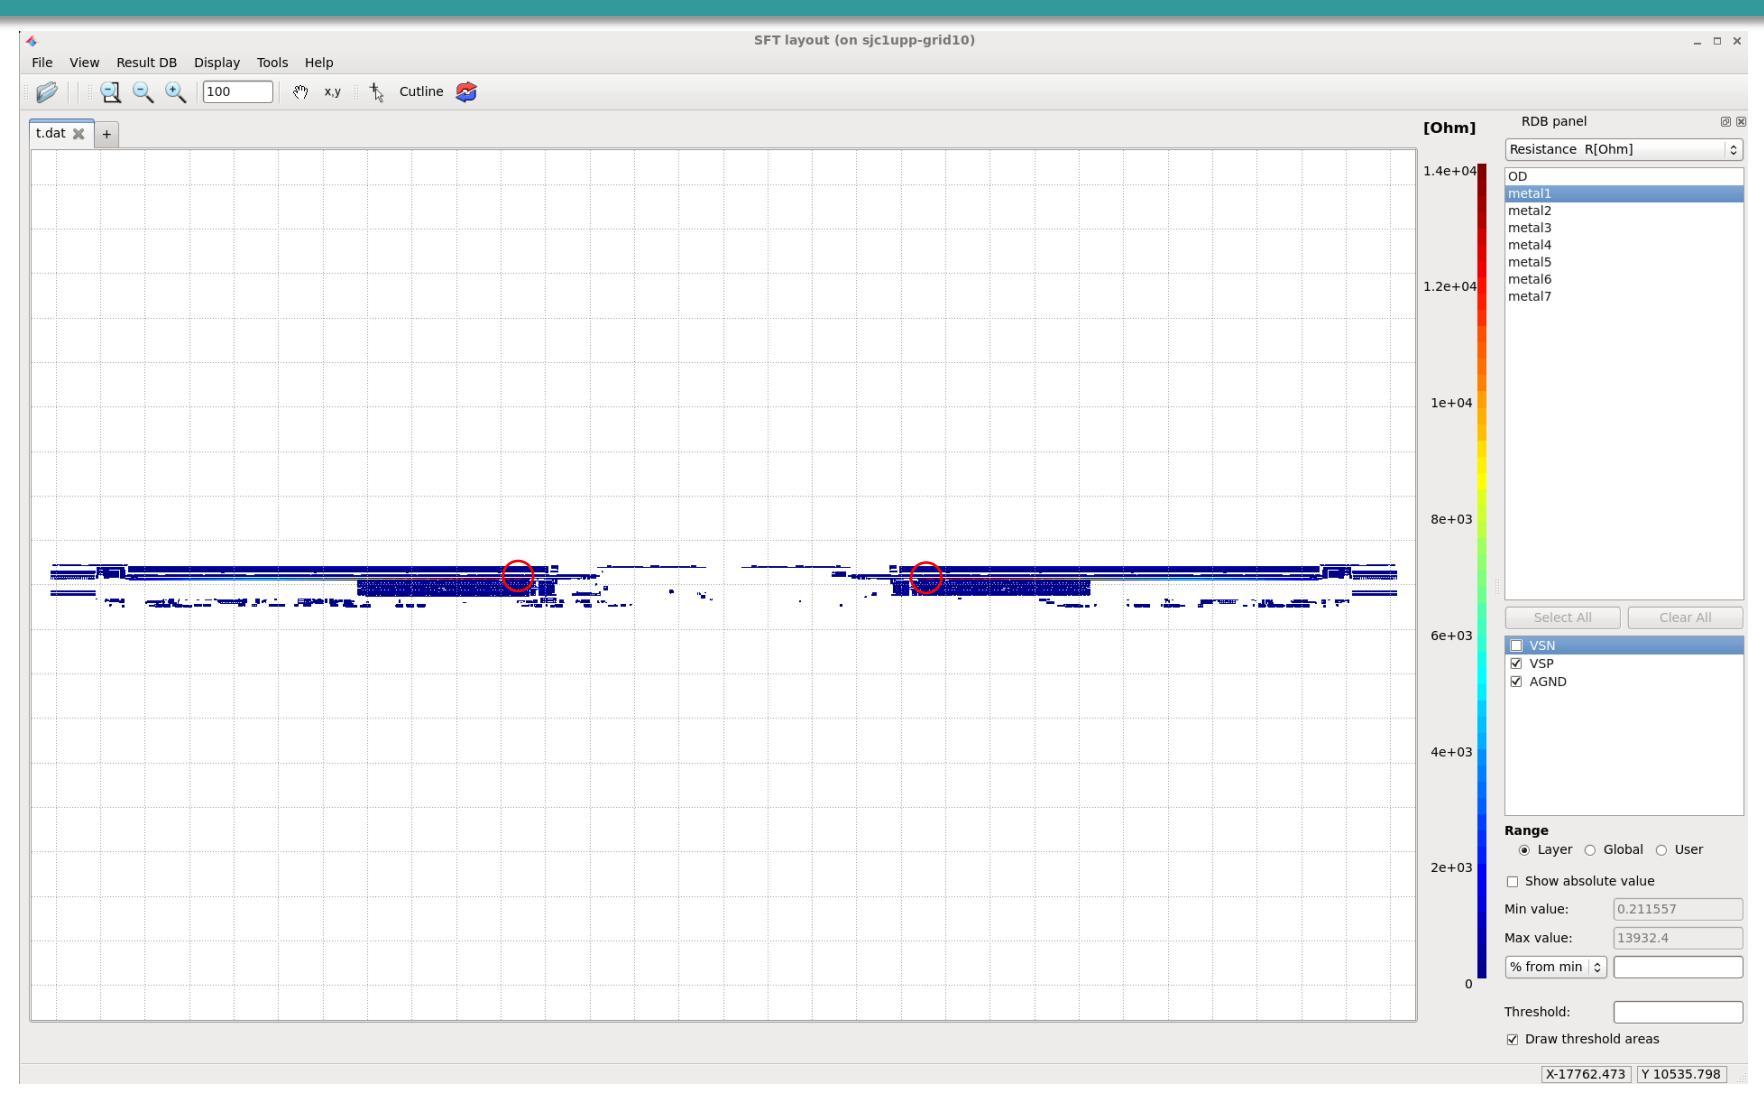
# Figure 7. Rmap of AGND and VSP supply networks along with damage locations in red circles

During IEC-61000-4-2 contact discharge to the ground plane of an fPCB that was part of a face down display module, damage occurred to an internal circuit that had been used in multiple earlier designs without issue. The damage looked like latch-up.

- Analysis of the ESD network for the block in question did not raise any red flags
- As shown in Figures 7 and 8, guard ring analysis found guard rings with resistances in excess of 13.8kΩ (VSP) and 12.6kΩ (AGND) adjacent to the failure location
- $\Box$  A three metal mask change reduced the resistance to less than 10 $\Omega$  on the AGND guard ring and less than 320 $\Omega$  on the VDD guard ring and fixed the problem

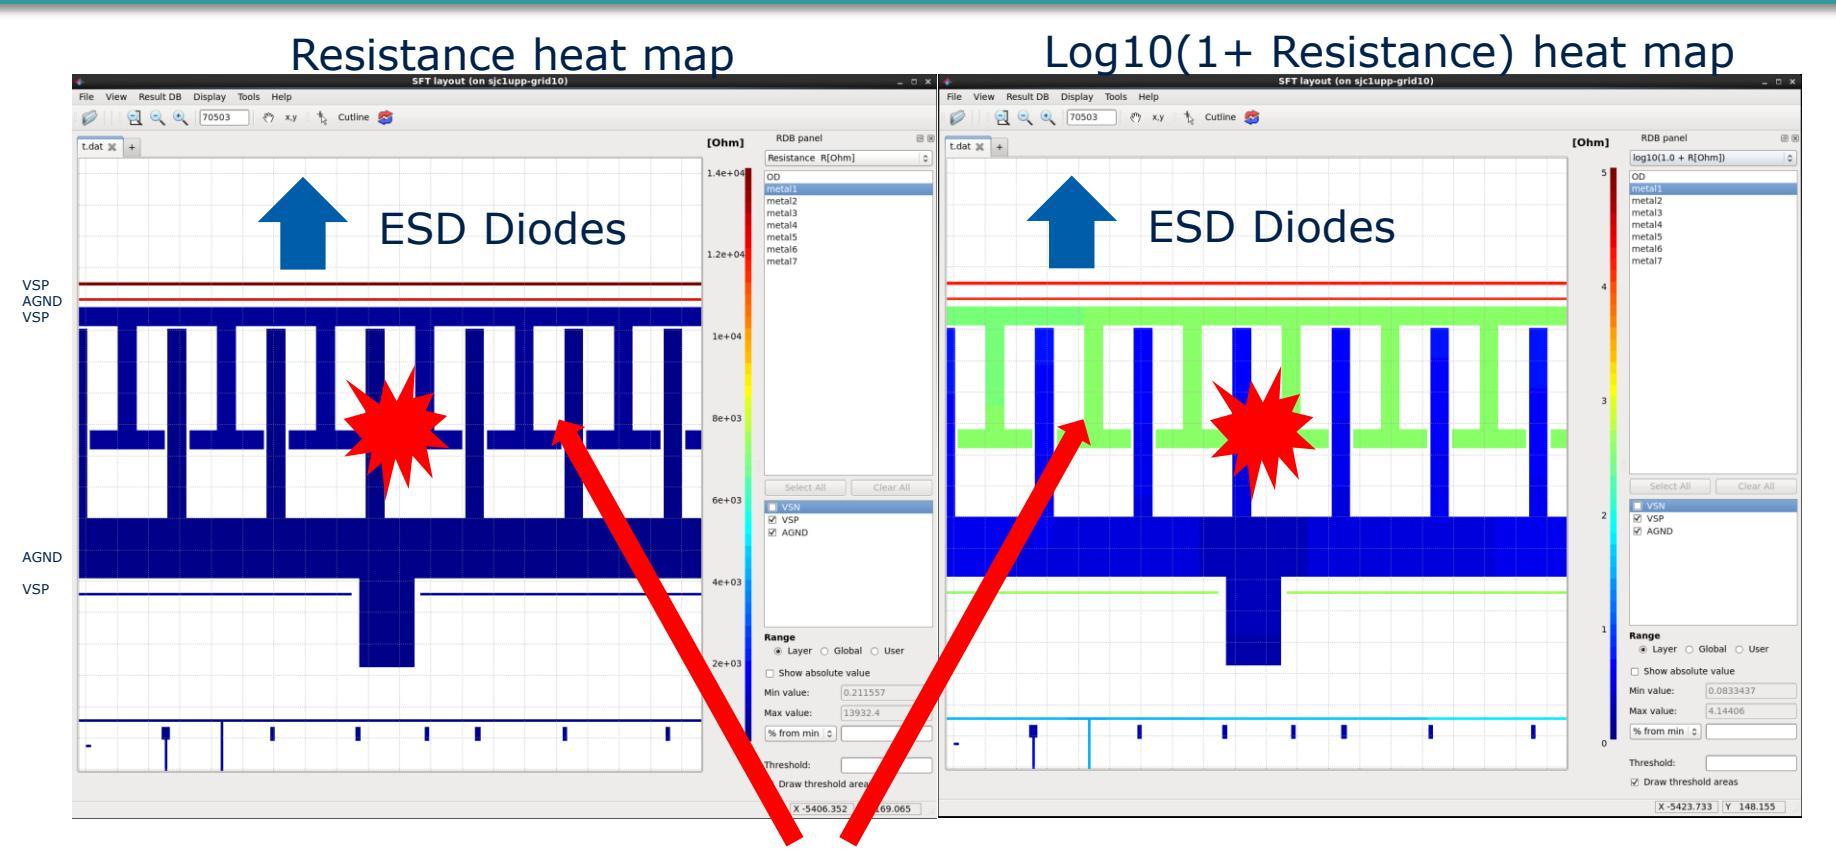
Figure 8. Zoomed in and annotated screen shots of Rmap for AGND and VSP supply networks next to damage location

NMOS and PMOS capacitor array with poor internal guard rings
