## Novel Full-chip Verification Methodologies for Domain-crossing and Transient Latch-up Damage Prevention

<u>David Klein, (Synaptics)</u>, Yuri Feinberg, Simon Young, (Silicon Frontline Technology)

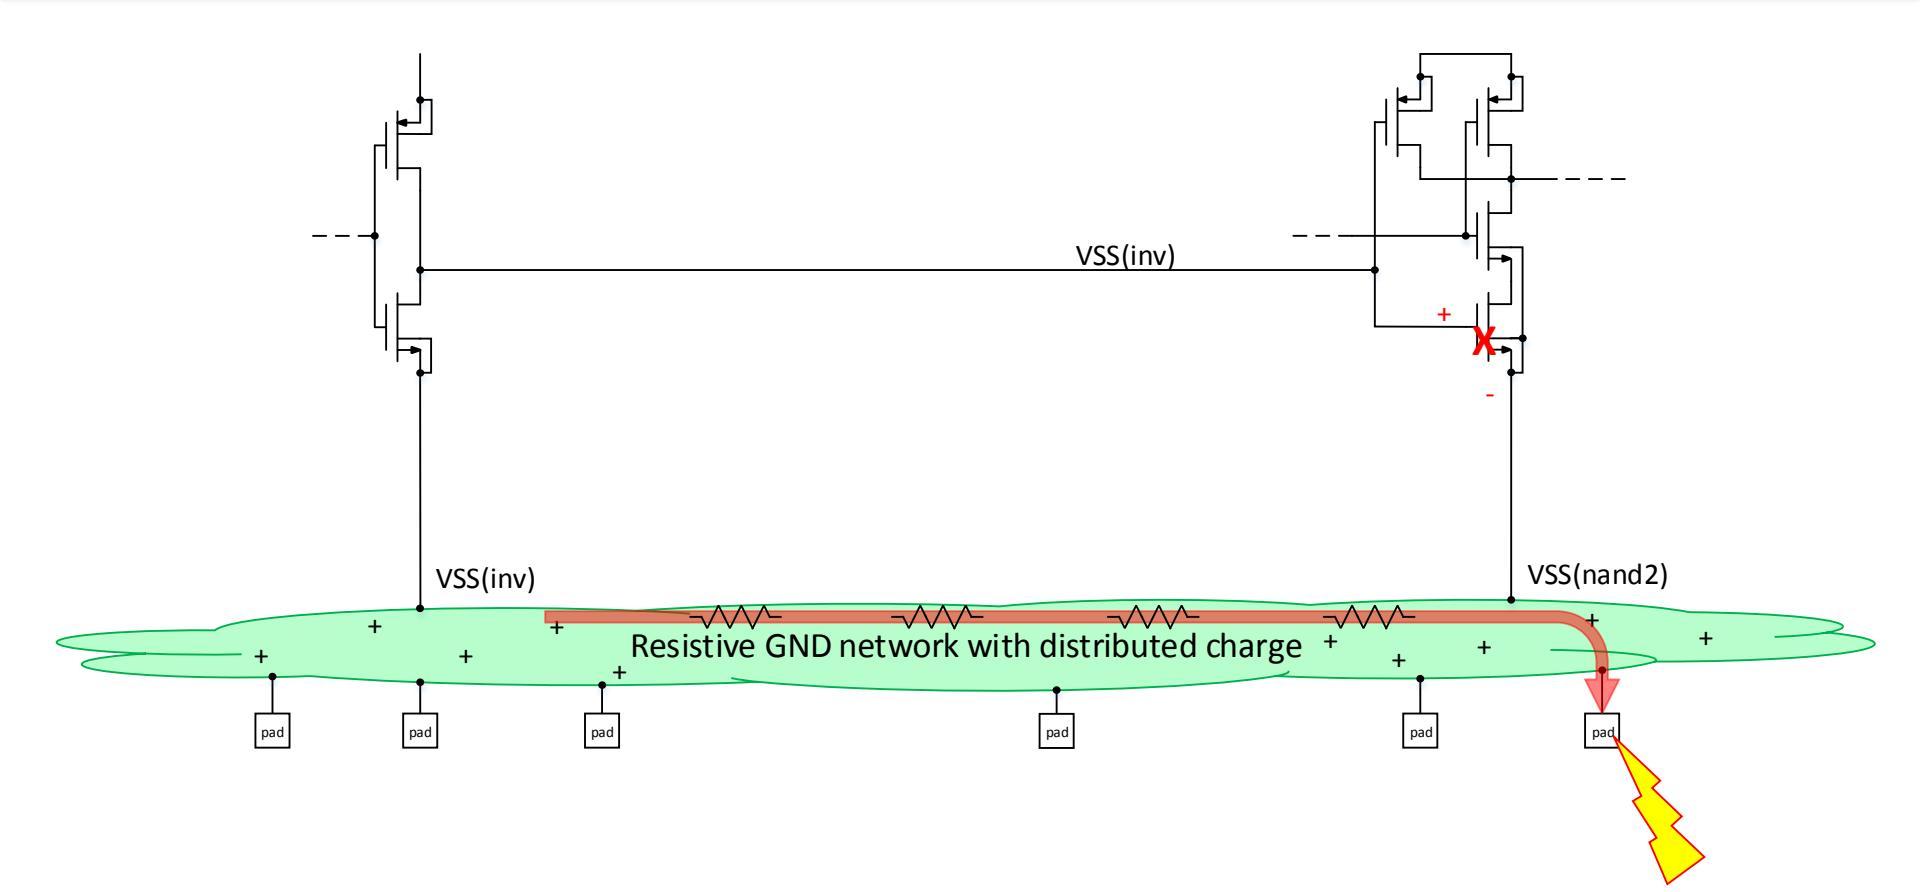
□ Gate oxide damage is more common for receivers of domain crossing signals. However, as shown in Figure 2, during an ESD event, even devices sharing the same supplies can be damaged. The tool identifies receiving devices at risk for both domain crossing and intra-domain D/R pairs

Figure 2. Conceptual illustration of a D/R pair. The bottom NMOS in the NAND2 will have the voltage across its gate oxide,  $V_{GS}$ , determined by the current through the resistive GND network. If  $V_{SS(inv)} - VSS_{(nand2)}$  is larger than the oxide breakdown voltage,  $V_{BDOX}$ , this NMOS is at risk during CDM and IEC testing.

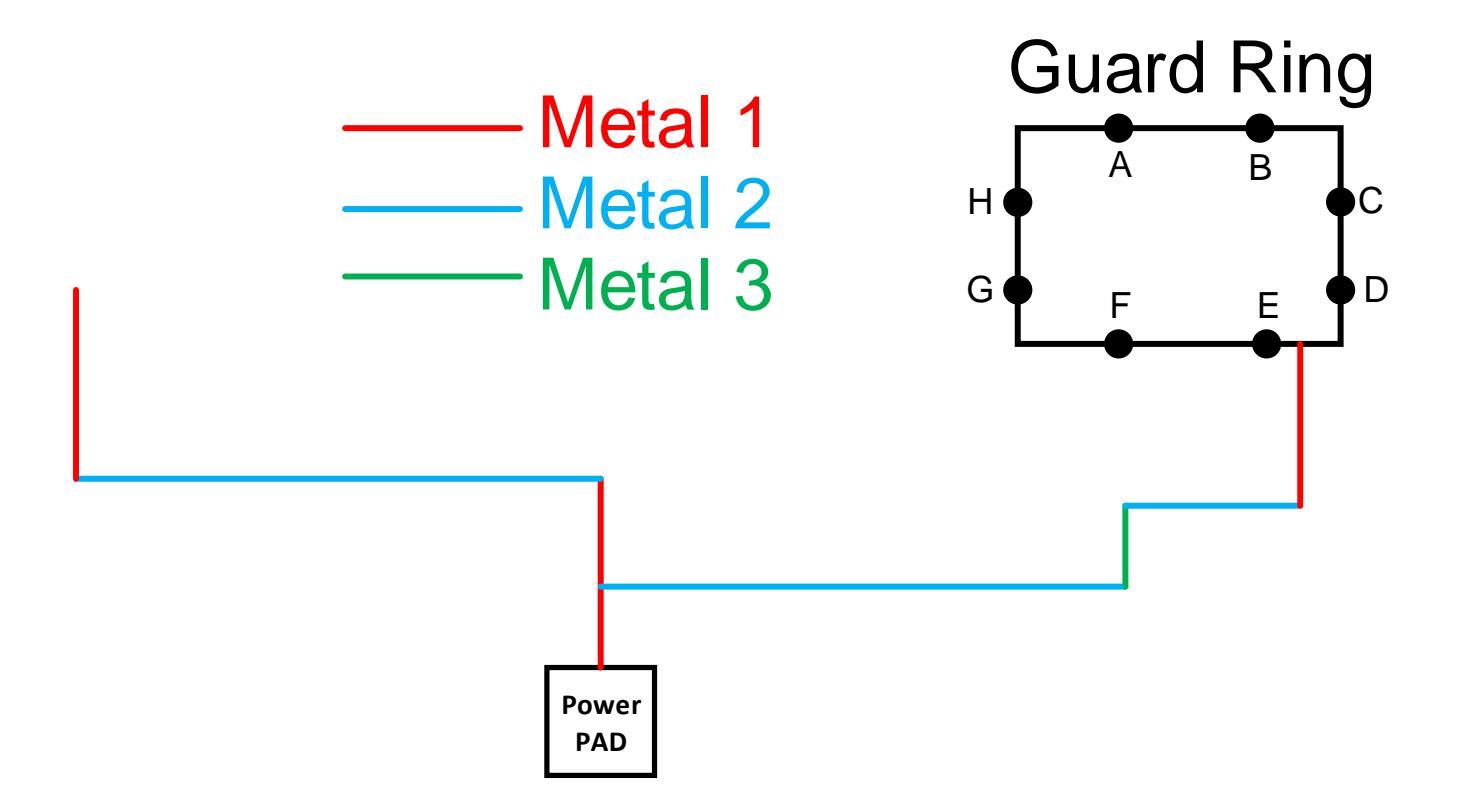
- □ As shown in Figure 6, there are eight sample points (A-H) on the guard ring
- Output is a graphical heat map for each supply and a text file with tables of the location of the highest resistance per layer for each supply

Figure 6. Conceptual illustration of the guard ring analysis. The tool calculates the resistance from each sample point (A-H) to the power pads.
